GROUT INJECTION SPECIALISTS

JOB DESCRIPTION
Ground collapse
28 Holland Road, Spalding

JOB No: 5737

DATE: 8th Oct 2007

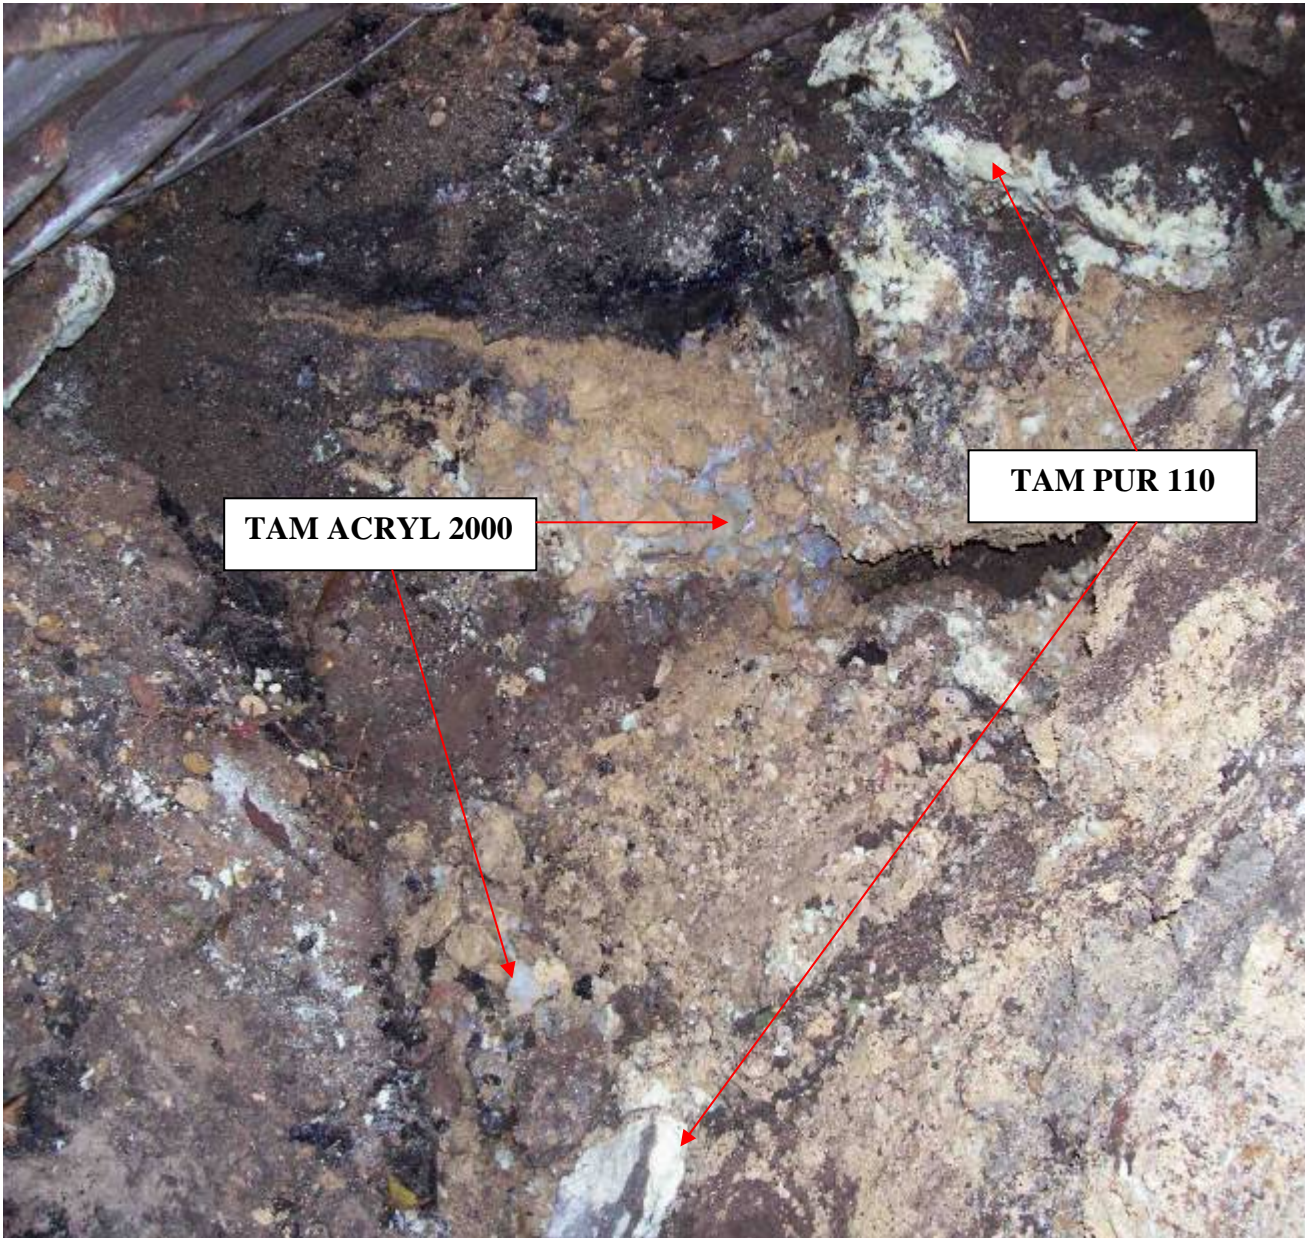
Excavated face showing fullness of lenses and fissures in order to arrest settlement in marginal soils.

Tam Pur 110 & Tam Acryl 2000 injections
